Wind Mitigation

Turtle Creek Association #1 Inc.
8 SE Turtle Creek Dr
Tequesta, FL 33469
October 10, 2023

Uniform Mitigation Verification Inspection Form

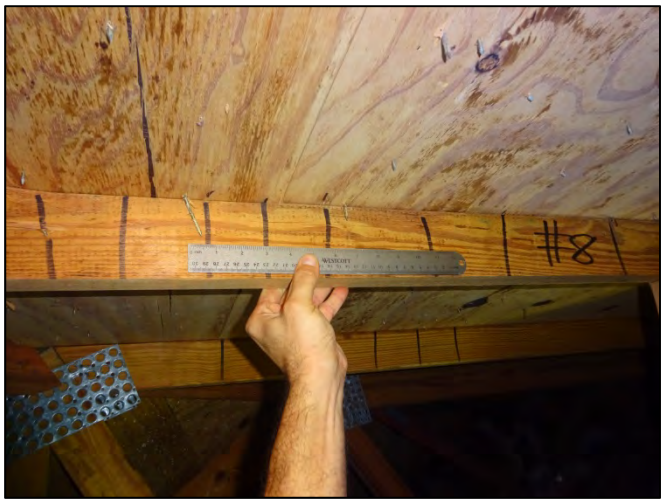
8d Nails

19/32” Sheathing
